Evaluation of the Automated Laser Rut Measurement System Used by the Ohio  
Department of Transportation

A thesis presented to  
the faculty of  
the Russ College of Engineering and Technology of Ohio University

November 2011

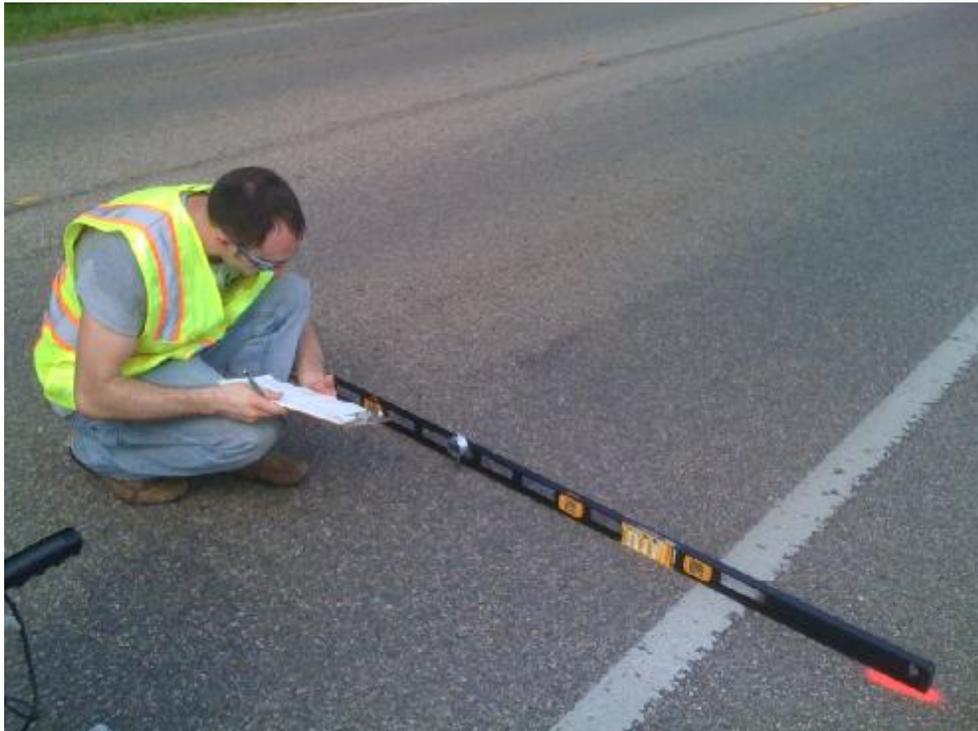
*Figure 2.1. Measurement of rut using a straight edge and electronic dial gage*

The most traditional technique for measuring rut depth is the straightedge method. This requires one to lay a straightedge across the wheel path perpendicular to the direction of traffic. The straightedge should contact the road at the two highest points on either side of the wheel path. The ASTM specification for this method requires that the straightedge be at least 1.73m (5.67ft) in length to ensure that it spans the entire width of

the rut (ASTM E 1703/E 1703M, 1995). Using a gauge, several measurements along the length of the straightedge should be taken to find the deepest point in the rut. This method, while simple and accurate if proper technique is used, can be time consuming and difficult to perform especially with limited traffic control.

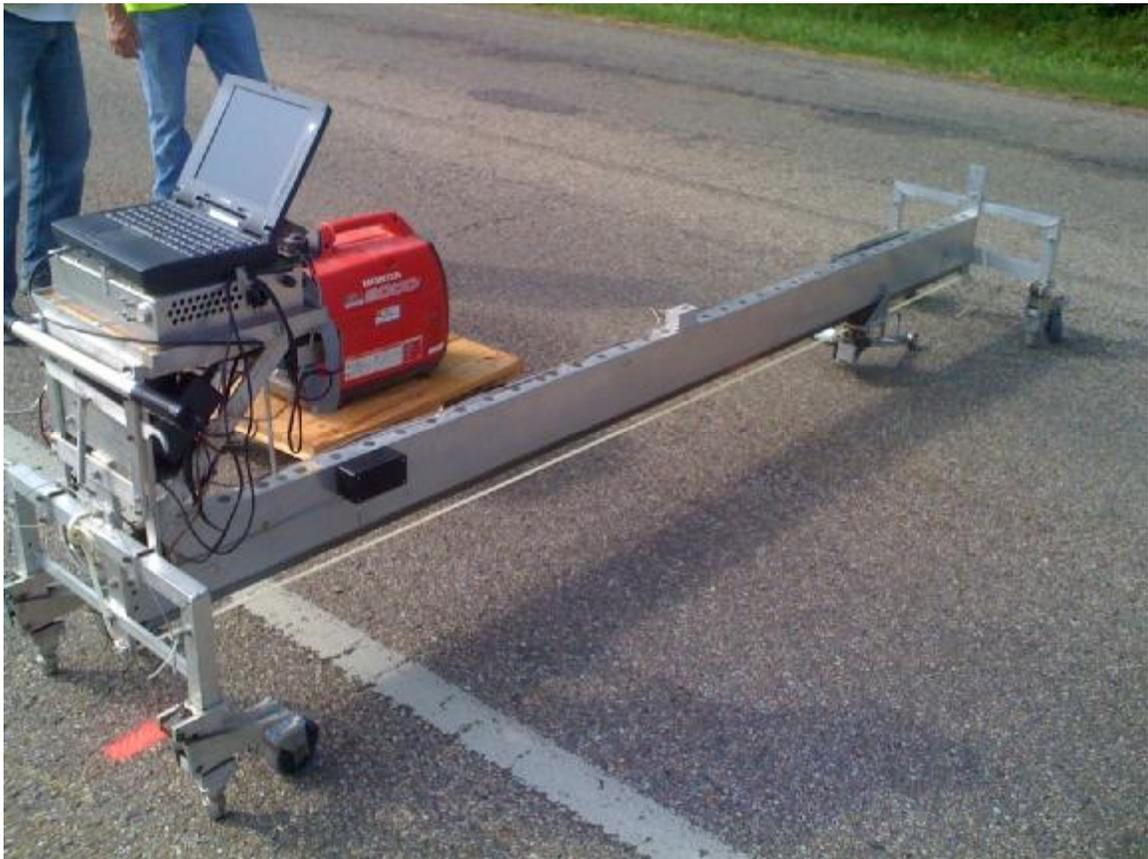
*Figure 2.4. ORITE profilometer measuring a transverse profile on SR-682*

The Ohio Research Institute for Transportation and the Environment (ORITE) designed and constructed a mechanical profilometer for measuring surface deformation at the ORITE Accelerated Pavement Loading Facility. The device creates a profile by measuring the distance between the pavement surface and an aluminum beam that serves as a guide rail. A carriage hangs below the guide rail with a 12-in (30.5-cm) arm extending down to the pavement. A 2-in (5.08 cm) diameter wheel is connected to the end of the arm that allows it to roll over the pavement surface. The carriage is driven back and forth along the rail by an electric motor. Its movement is tracked using a quadrature rotary encoder. The angle of the arm changes as the wheel travels over the uneven pavement. This angle is measured to a precision of 0.025 degrees using an incremental rotary optical encoder. A DOS program, written specifically for the ORITE profilometer, uses the measured change in angle to calculate the tangential displacement of the wheel at the end of the arm. A change of 0.025 degrees measured by the rotary encoder would indicate approximately 0.005 inches (0.127 mm) of movement at the end of the arm. An inclinometer mounted at the center of the beam is used to measure the slope of the beam during each profile measurement. This allows profiles to be rotated or leveled to create a more accurate model of the pavement. The inclinometer makes it

possible to level each profile in a series to produce an interpolated, three-dimensional profile of a segment of roadway (Richardson, 2003).

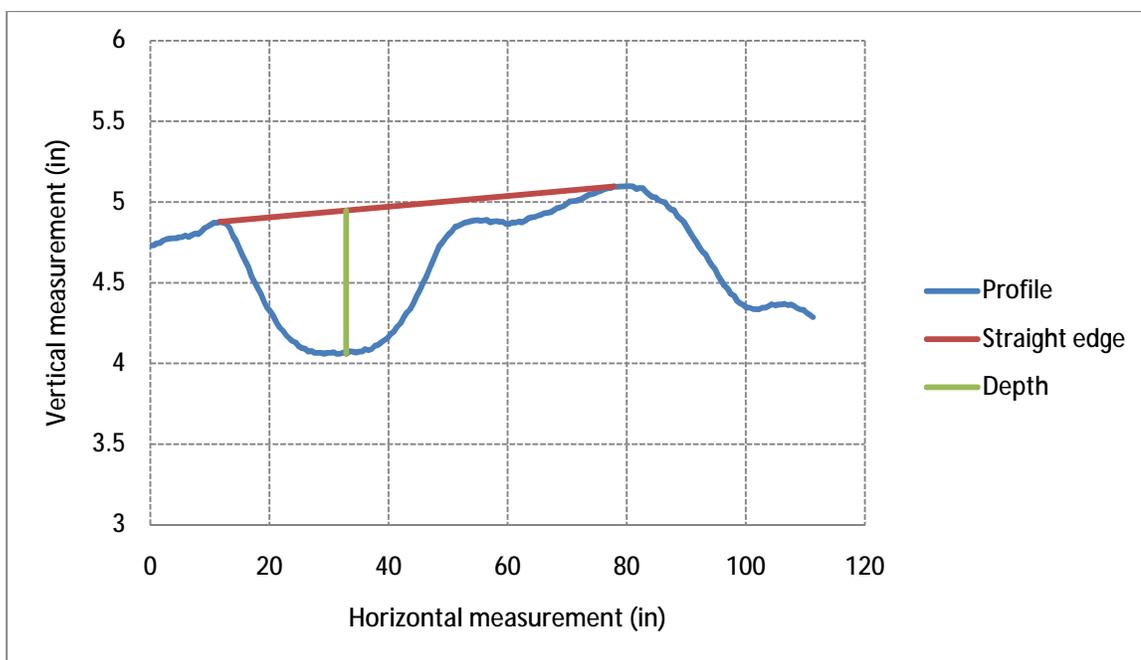
**Figure 2.5. Typical virtual straight edge model using ORITE profilometer data from US-30 (1 in = 2.54 cm)**

In order to measure the rut depth from the profilometer readings, a method for simulating a 2-m (6.56-ft) straight edge was developed using MATLAB. In order to find the rut depth, two ranges are specified by the user to indicate where the left and right ends of the straight edge may contact the pavement. Lines are drawn from each point within the left range to each point within the right range. Lines are limited to a length of 2 m. Every time a line is drawn, a vertical measurement is taken from the connecting line to

the pavement surface at every point between the left and right ends. The largest measurement after all possible left and right endpoint combinations are considered is recorded as the rut depth. The rut width is recorded as well. This was done for each of the profiles collected in both wheel paths. An example of the resulting virtual straight edge created by the program is shown in Figure 2.5. Just like in the case of an actual straight edge measurement, the maximum possible depth is found when the virtual straight edge is tangent to the plotted curve at two points near the peaks on either side of the rut.

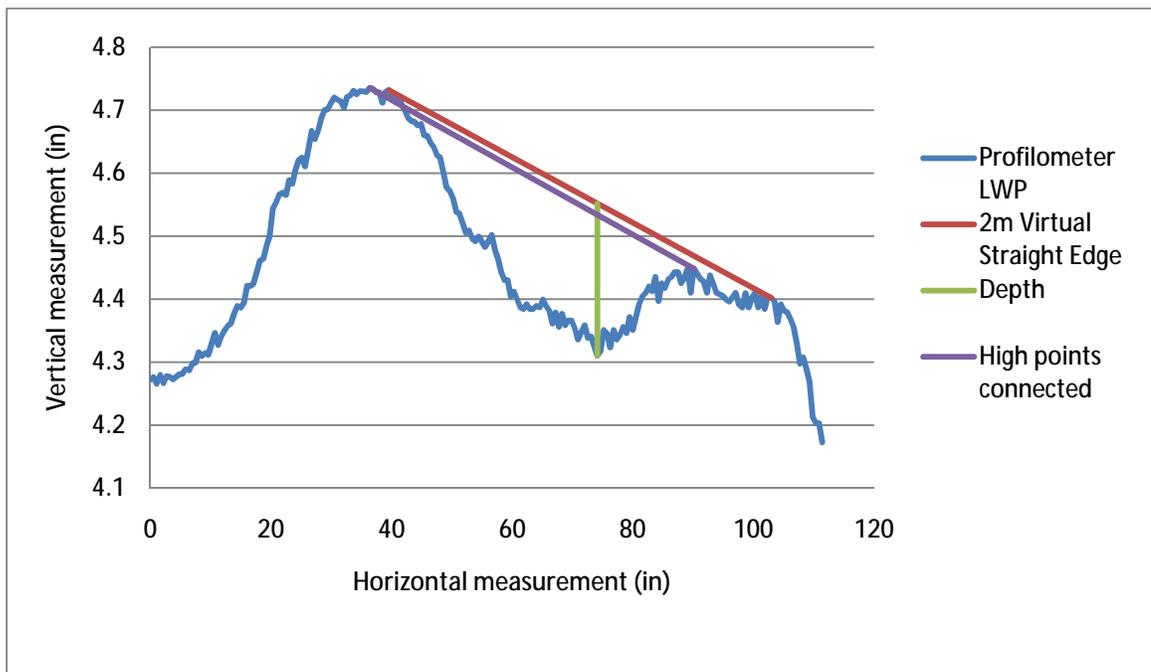
**Figure 2.8.** *Illustrated difference in virtual straight edge model described in Tsai, et al (2010)*

pavement near the high points. Also, the lower side of the straight edge would likely rest at a point beyond the highest point. An example of this is shown in Figure 2.8. This plot uses profilometer data gathered in the left wheel path on SR-682 to demonstrate the difference in virtual straight edge algorithms. As one can clearly see, the line connecting the highest points on either side of the rut would cause the rut depth to be underestimated slightly.

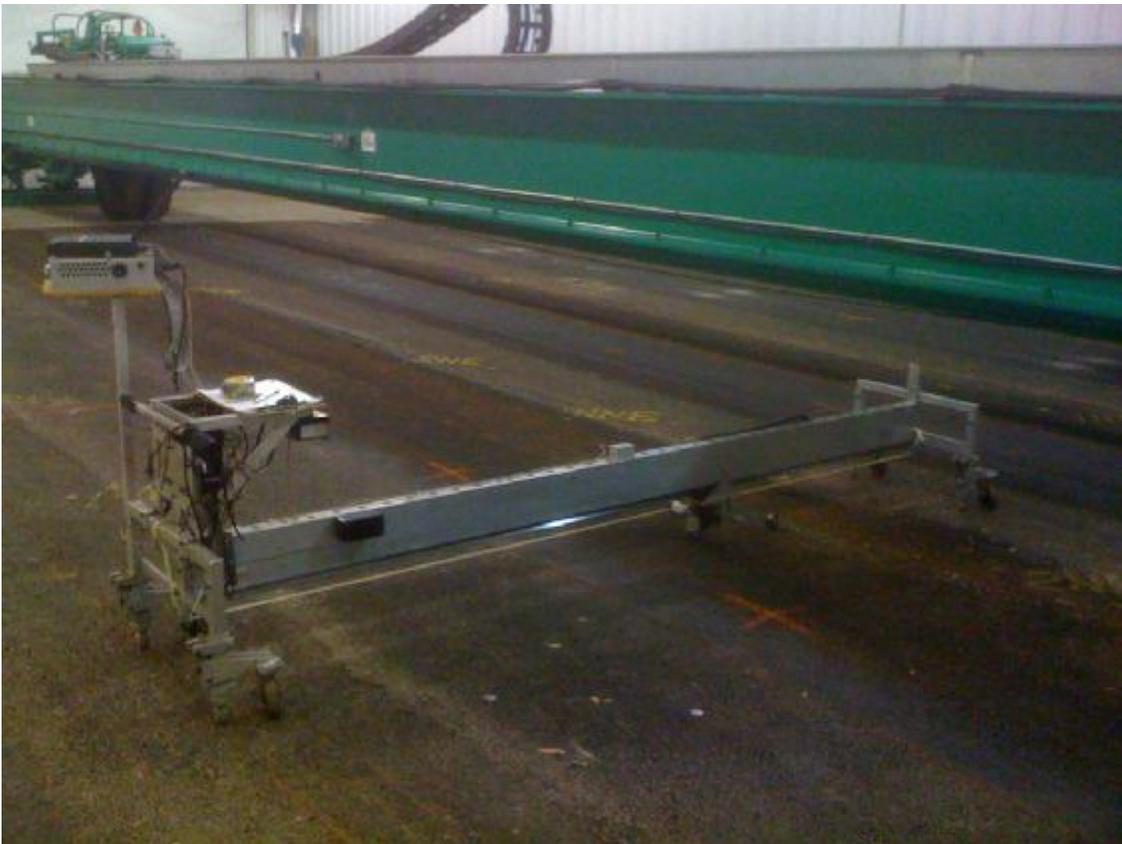
***Figure 3.1. Profilometer measuring rut depth at the Accelerated Pavement Loading Facility (APLF)***

The three pavement sections were measured at 1-ft intervals using the S&G and Profilometer. The depth of each side of the double rut was measured and recorded. It was believed that the larger of the two depth measurements would be the depth reported

by the LRMS. Five runs were made with the profiler vehicle on each lane. The front bumper of the vehicle was aligned with first of the 1-ft measurement intervals, recording was started, and the operator accelerated until the vehicle was completely clear of the pavement section, at which point recording was stopped. The system recorded rut depth at 5-ft intervals.

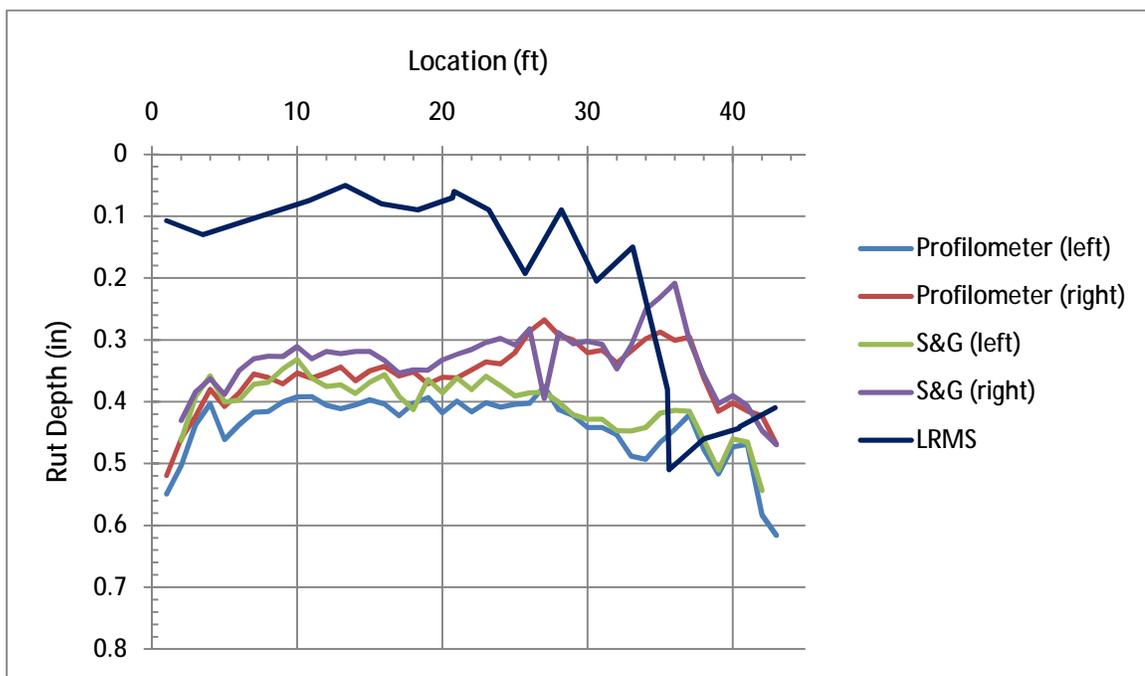
**Figure 3.2. Rut depths measured in lane 2 at the APLF**

The rut depths collected using the LRMS differed dramatically from the profilometer and S&G. It was immediately evident that the system was not measuring the ruts at the APLF correctly. The output also contained numerous saturation errors. The results are shown in Figure 3.2 through Figure 3.4 with the data points that were flagged for errors removed.

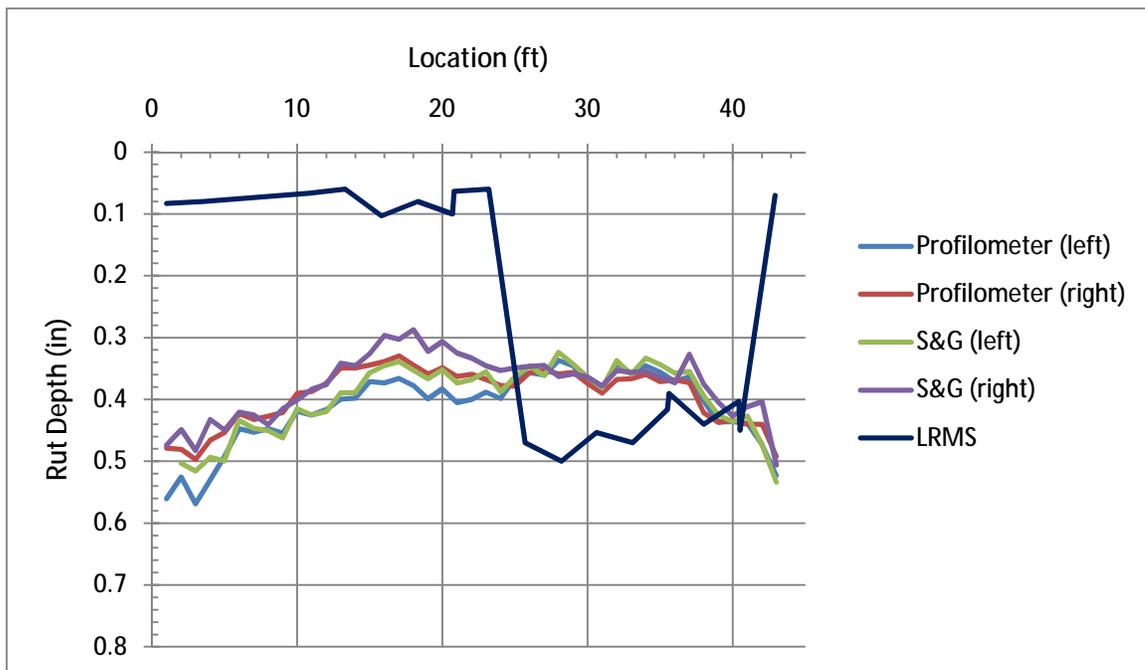
Figure 3.3. Rut depths measured in lane 3 at the APLF

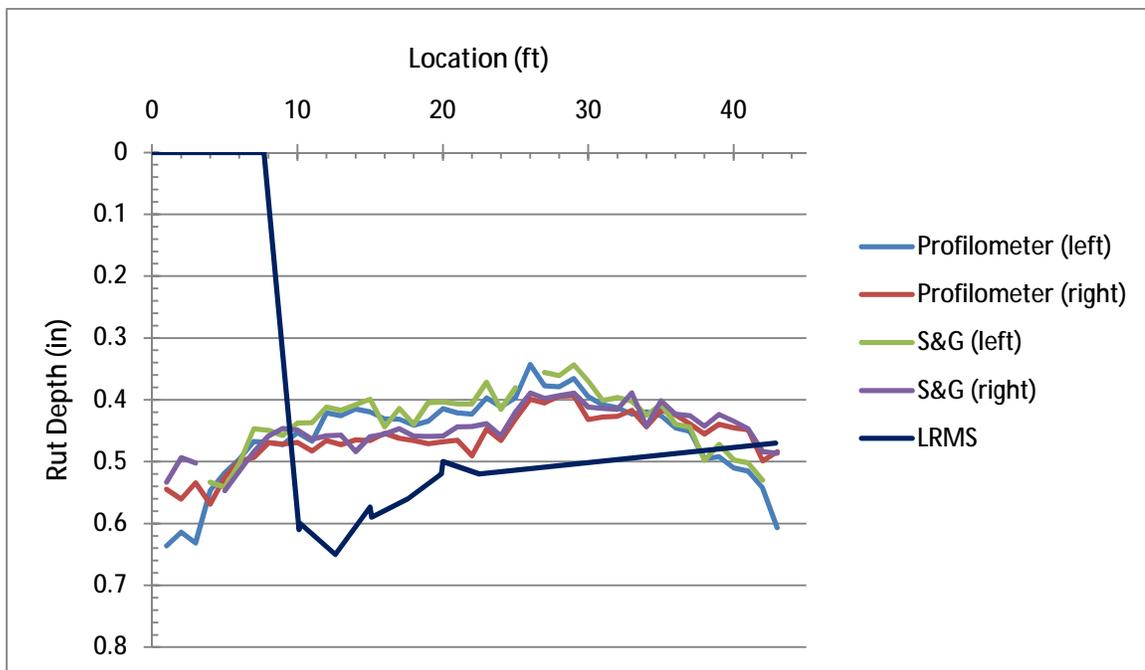
Figure 3.4. Rut depths measured in lane 4 at the APLF

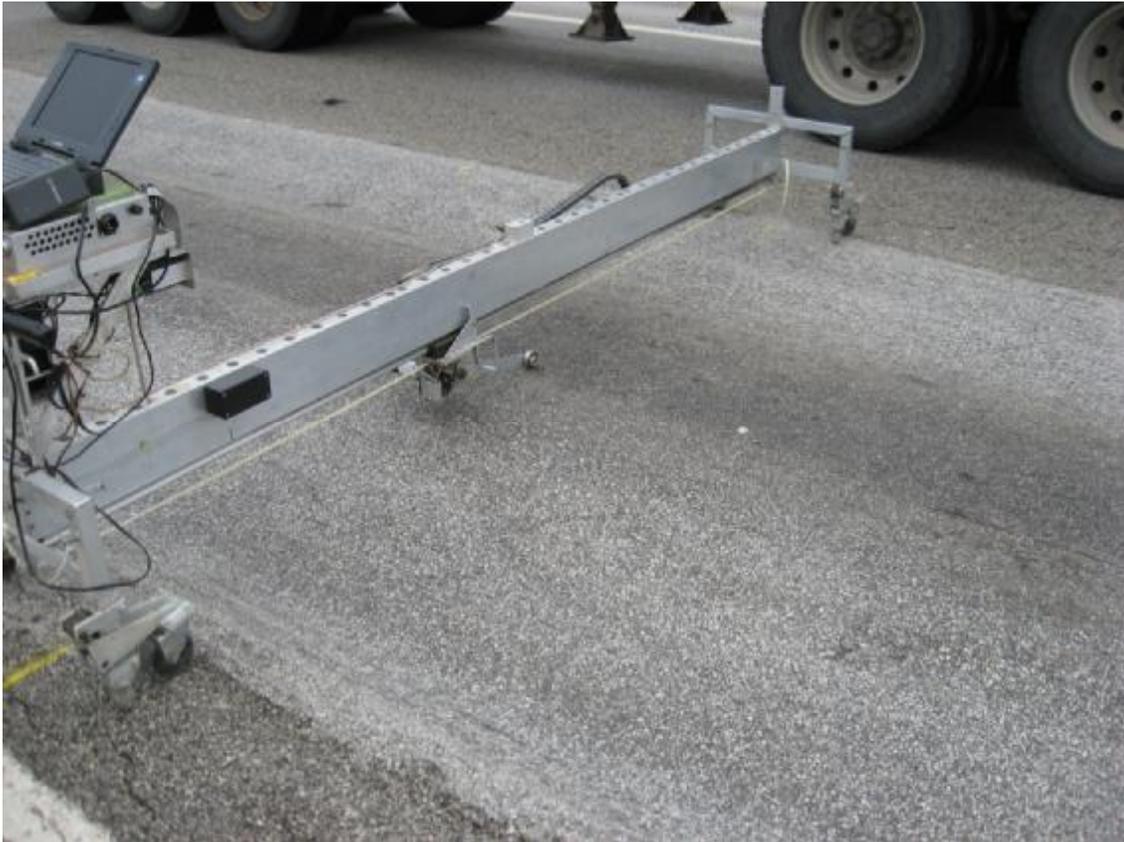
***Figure 4.2. Measuring rut depth on US-30 using the ORITE profilometer***

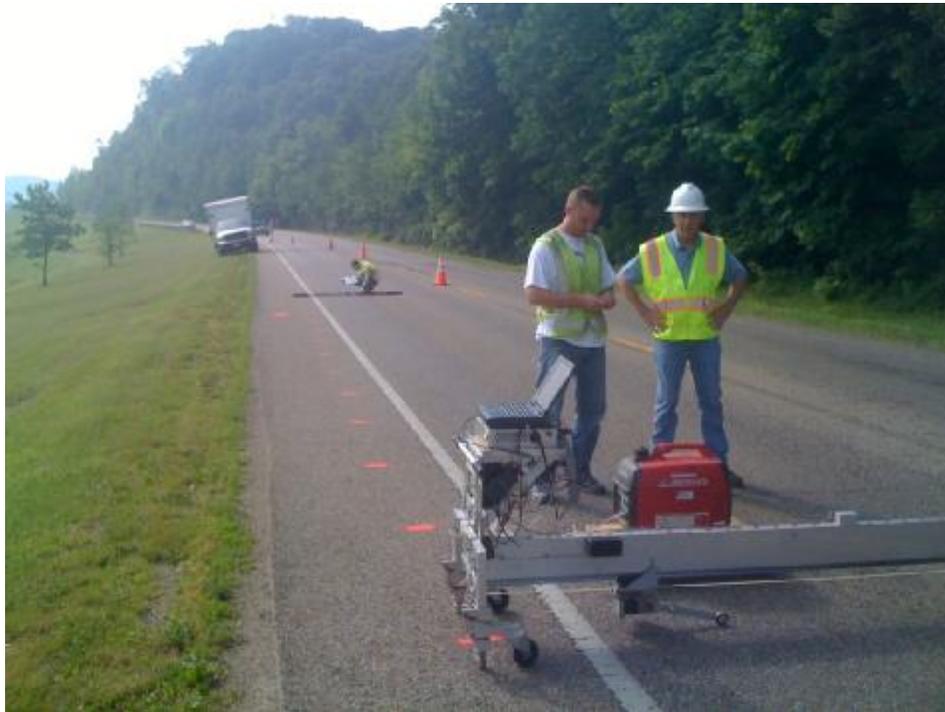
***Figure 4.4. Rut measurement on SR-682 using the profilometer and 8-ft S&G***

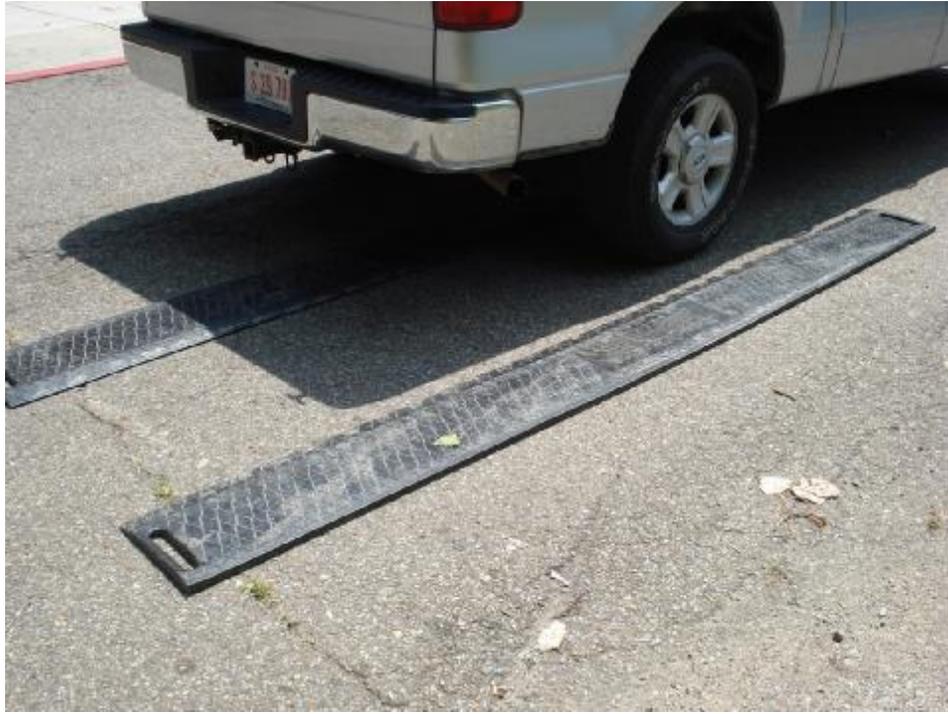
*Figure 4.5. Temporary rumble strips used to create an artificially deep rut to be used as a reference point in the LRMS data*

Unlike the US-30 test, there was no clearly defined section of severe rutting that could be used as a reference point for aligning data sets. To compensate, a reference point was created at the start of the 200-ft test section by creating a sort of artificial rut that would be easy to distinguish from other areas of the pavement. This was achieved by laying temporary rumble strips longitudinally in the road on both sides of the right wheel path. This artificially raised the sides of the wheel path to simulate a deeper rut and produced a spike in depth measurements that was used to align each set of data (see Figure 4.5).

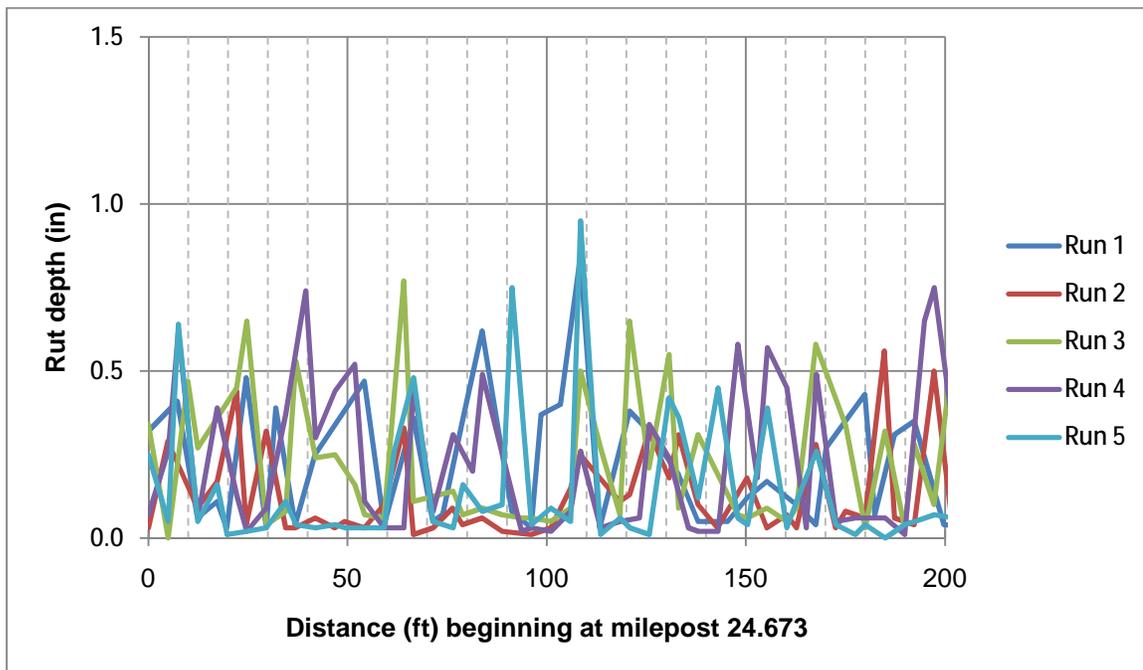
*Figure 4.6. Sample plot of LRMS data from the Pathway Services system on US-30 (RWP)*

Figure 4.6 through Figure 4.9 show Dynatest and Pathway Services data gathered in both wheel paths over the same sections of pavement. The Pathway Services measurements from the 200-ft test section are compared with the profilometer and straight edges in Figure 4.10 and Figure 4.11. The Pathway Services data points with saturation errors were removed from the data sets before these plots were made. As one can see in these figures, the Pathway Services plots show little or no similarity between runs and rut depth erratically fluctuating between 0.00 and 1.00 inches. Measurements from the left wheel path are slightly less erratic than the right, however there are still large spikes in the data and the plot from the 200-ft test section shows no correlation between the Pathway Services system and the other methods. Because of this, it was

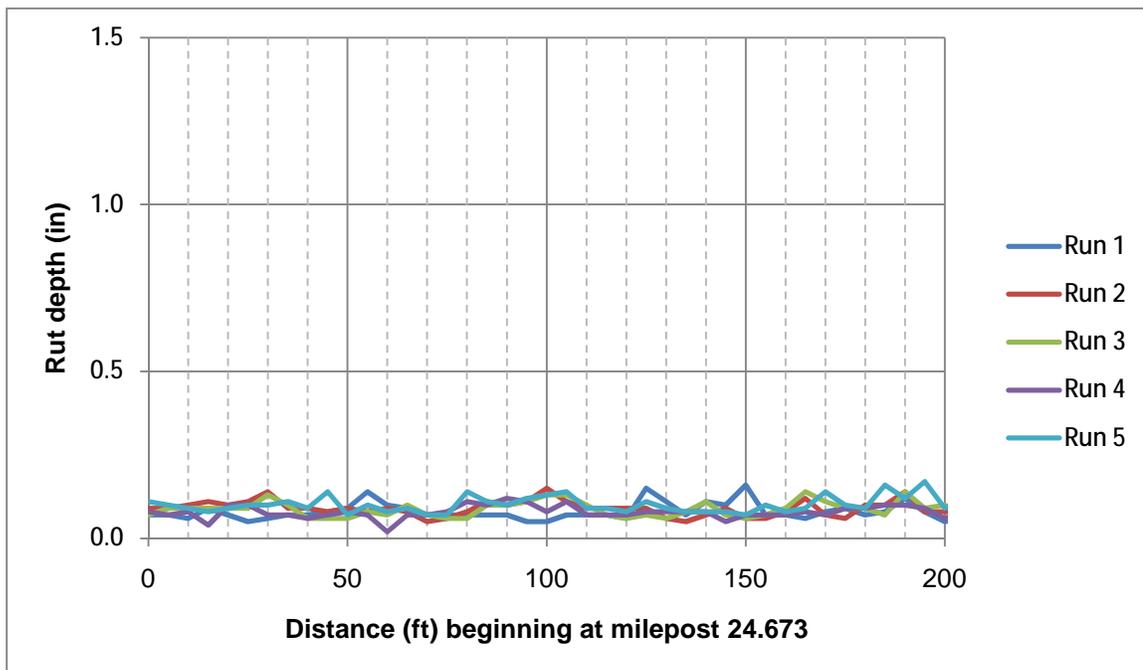
*Figure 4.7. Sample plot of LRMS data from the Dynatest system on US-30 (RWP)*

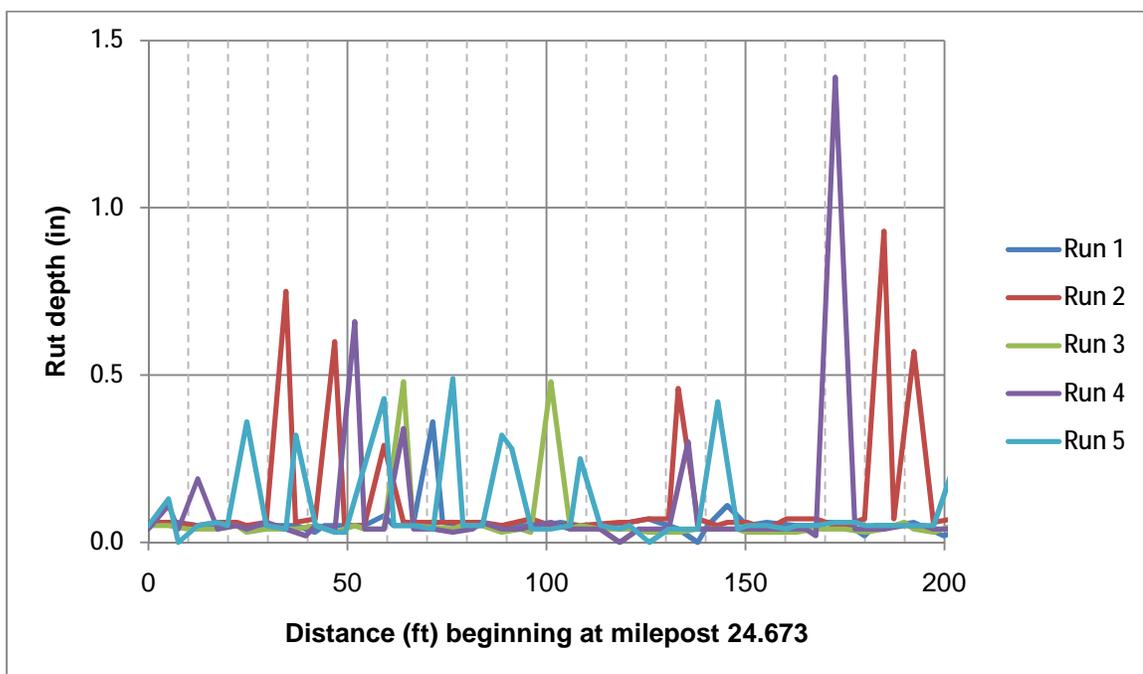
*Figure 4.8. Sample plot of LRMS data from the Pathway Services system on US-30 (LWP)*

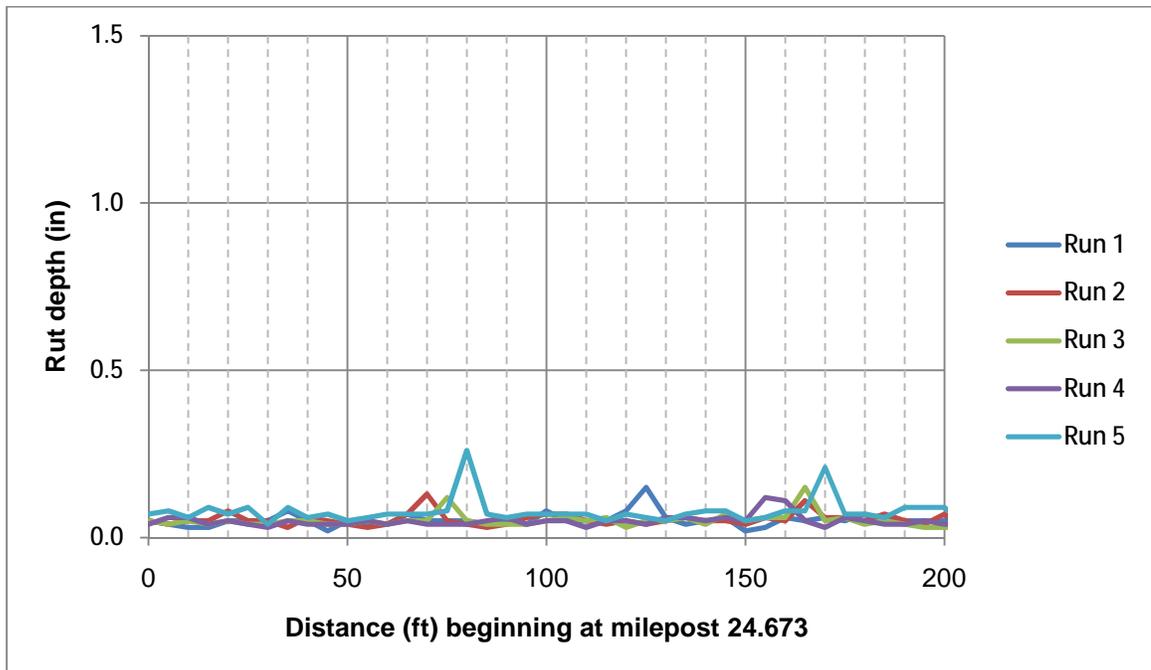
*Figure 4.9. Sample plot of LRMS data from the Dynatest system on US-30 (LWP)*

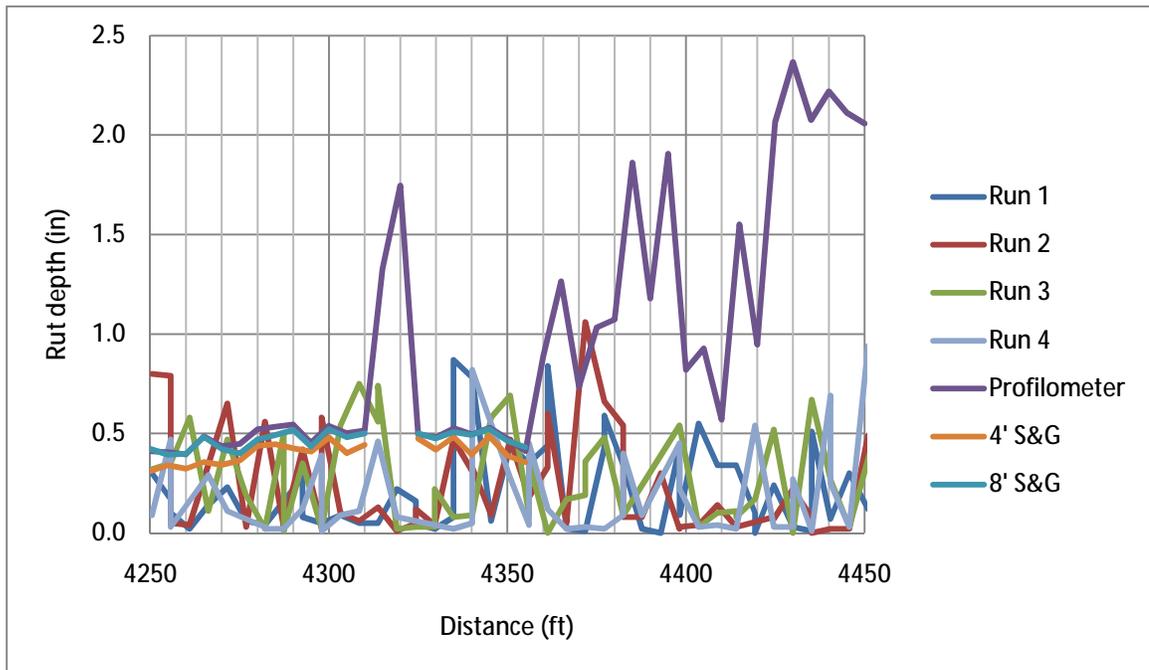
**Figure 4.10.** LRMS data from the Pathway Services system at the 200-ft test section on US-30 (RWP)

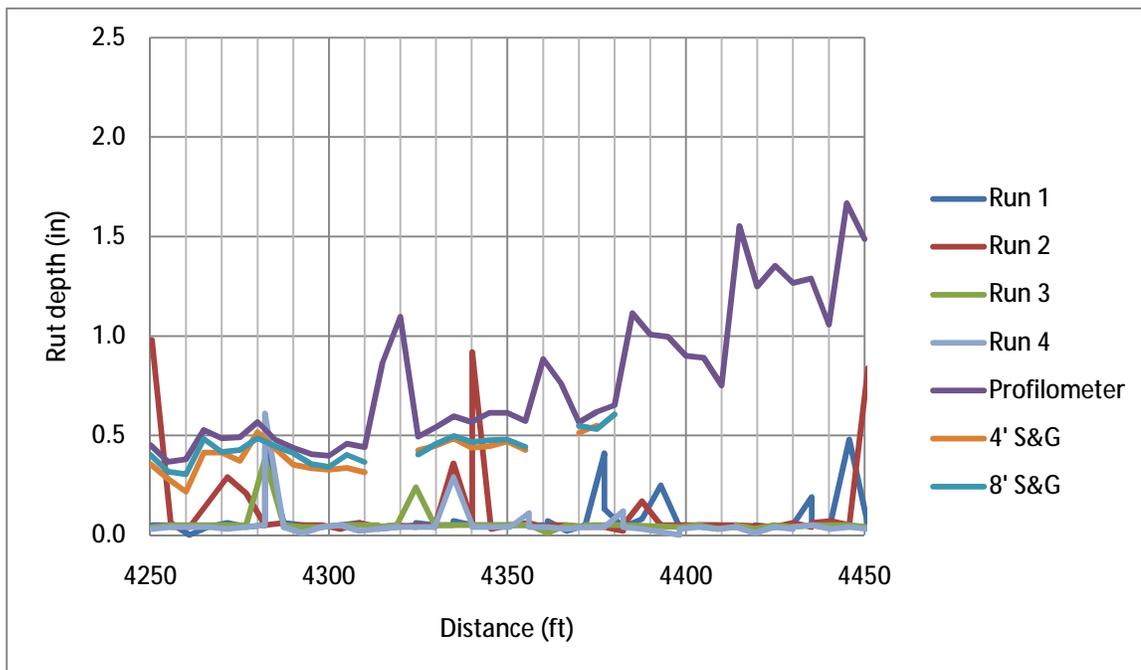
**Figure 4.11. LRMS data from the Pathway Services system at the 200-ft test section on US-30 (LWP)**

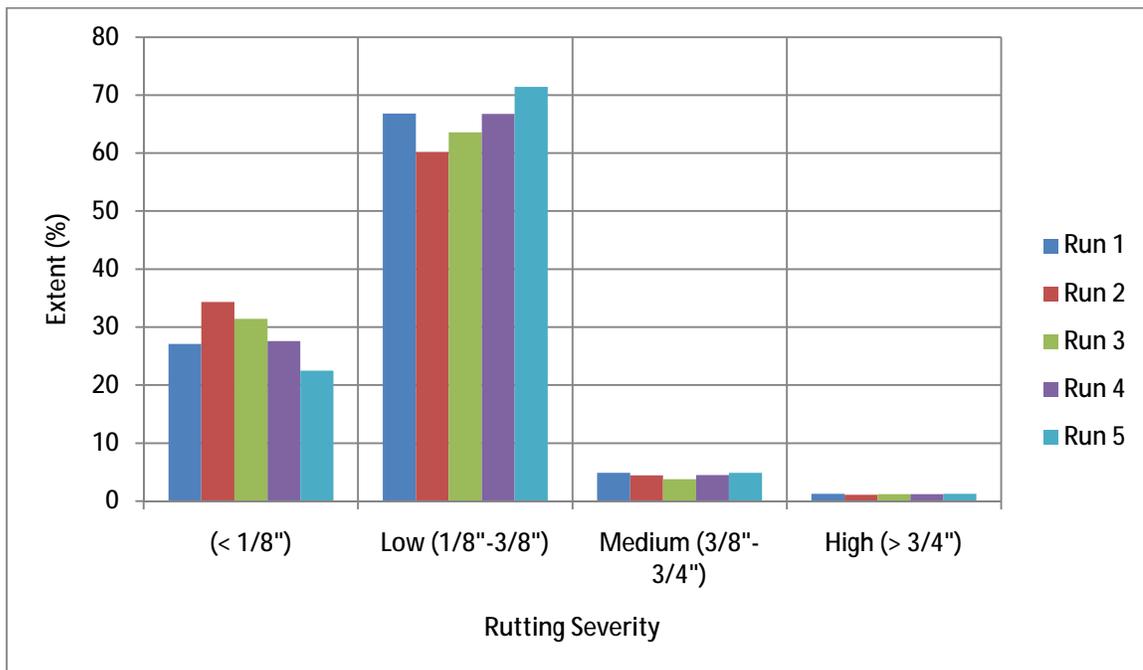
**Figure 4.12. Distribution of rutting by severity on US-30 (LWP)**

the distribution of rutting, shown in Figure 4.12 and Figure 4.13, suggest that the five runs would have all produced the same score using the ODOT pavement rating system.

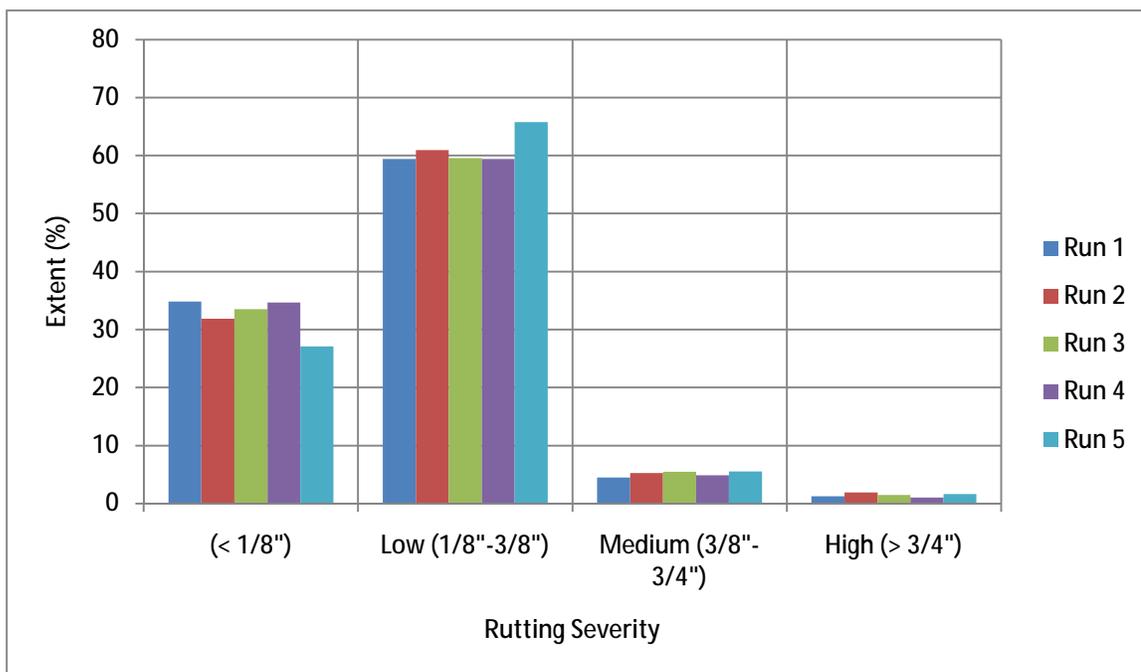
**Figure 4.13. Distribution of rutting by severity on US-30 (RWP)**

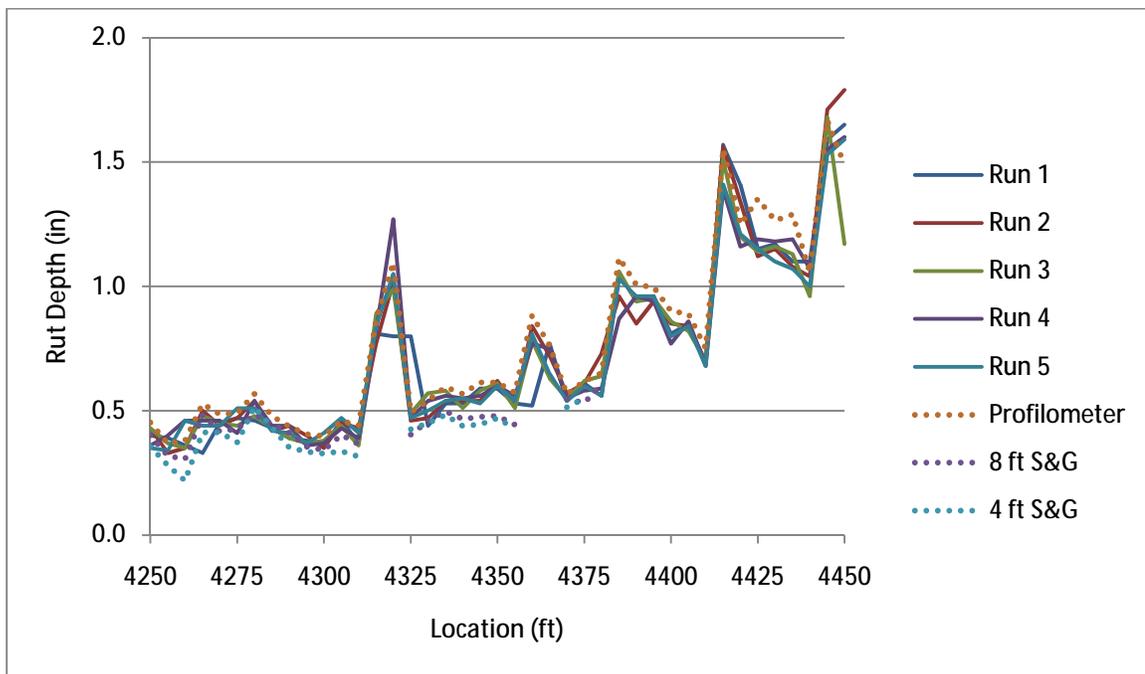
**Figure 4.14. Rut depth measurements from 200 ft (60.96 m) test section on US-30 (LWP) (1 in = 25.4 mm)**

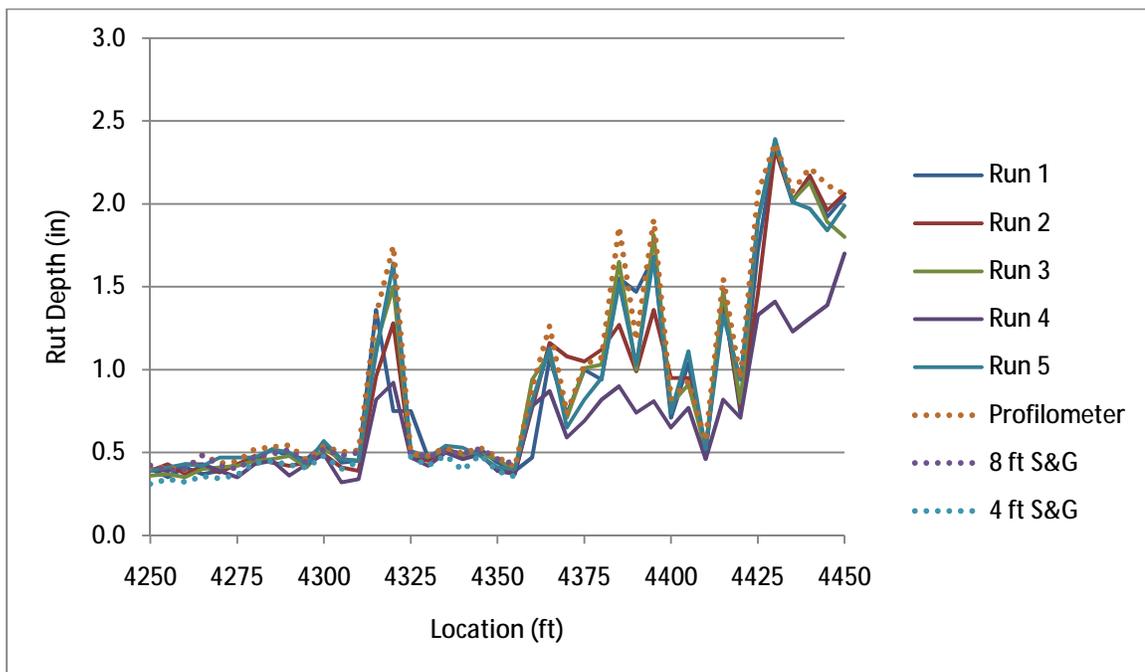
**Figure 4.15. Rut depth measurements from 200-ft (60.96 m) test section on US-30 (RWP) (1 in = 25.4 mm)**

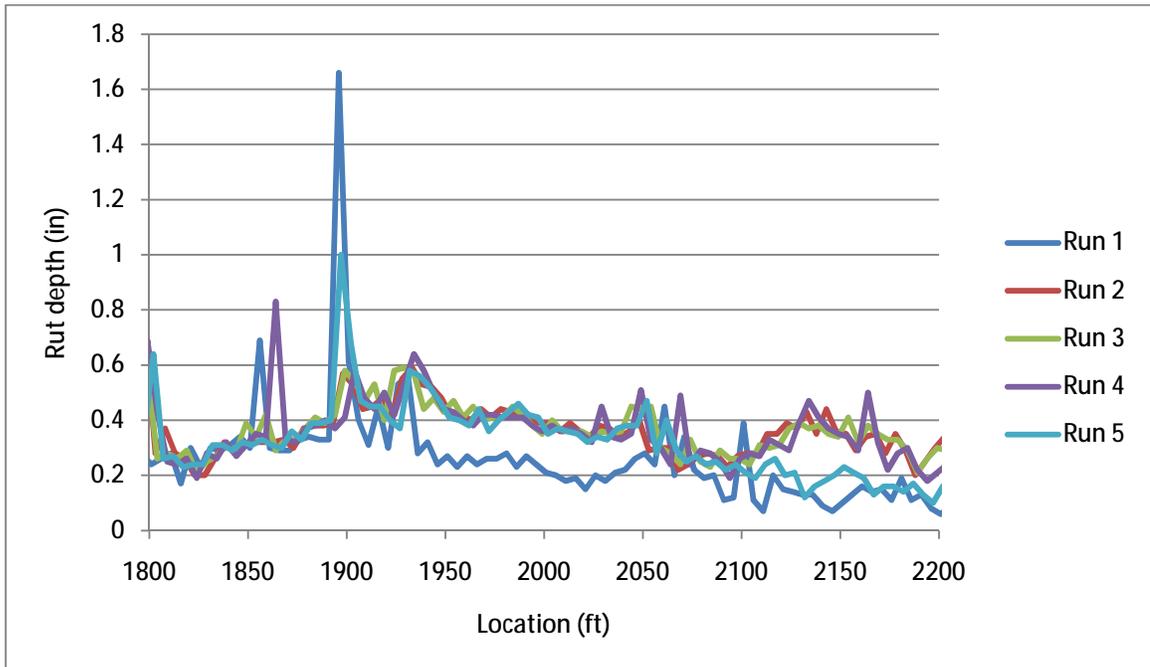
**Figure 4.16. Rut depth measurements from LRMS in the left wheel path on SR-682 (1800-2200 ft) (1 in =25.4 mm)**

The Games-Howell test shows a strong statistical similarity between each set of data from the right wheel path; however the left wheel path data from Run 1 do not correlate with the other data sets. There are a few instances where the measured rut depths from Run 1 are slightly less than the other runs over a short distance (see Figure 4.16). In these segments, the measured rut widths in Run 1 are also significantly less than the widths measured in other runs. This may suggest that the vehicle had drifted from the center of the lane or the laser system was being influenced by pavement deterioration observed at the center of the roadway (see Figure 4.17).

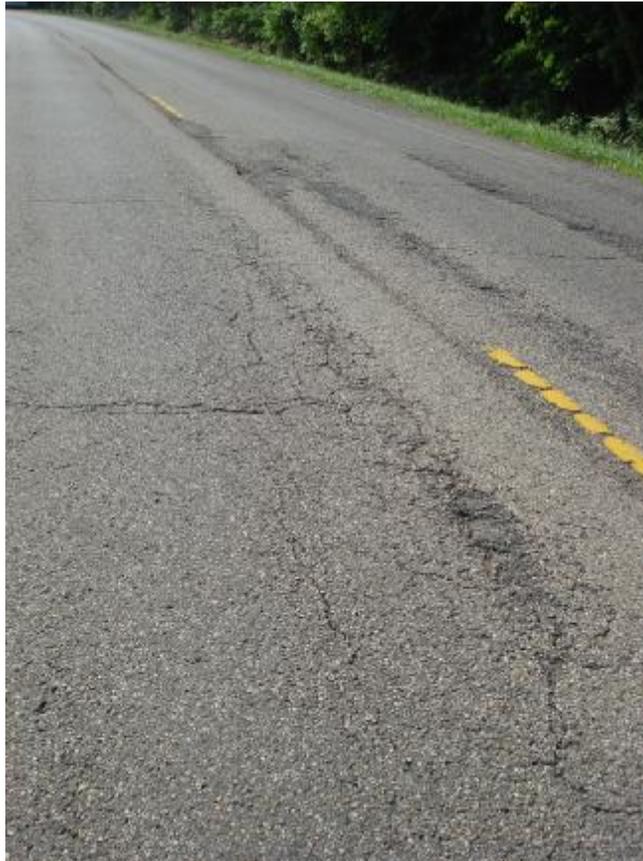
**Figure 4.17. Pavement deterioration on SR-682**

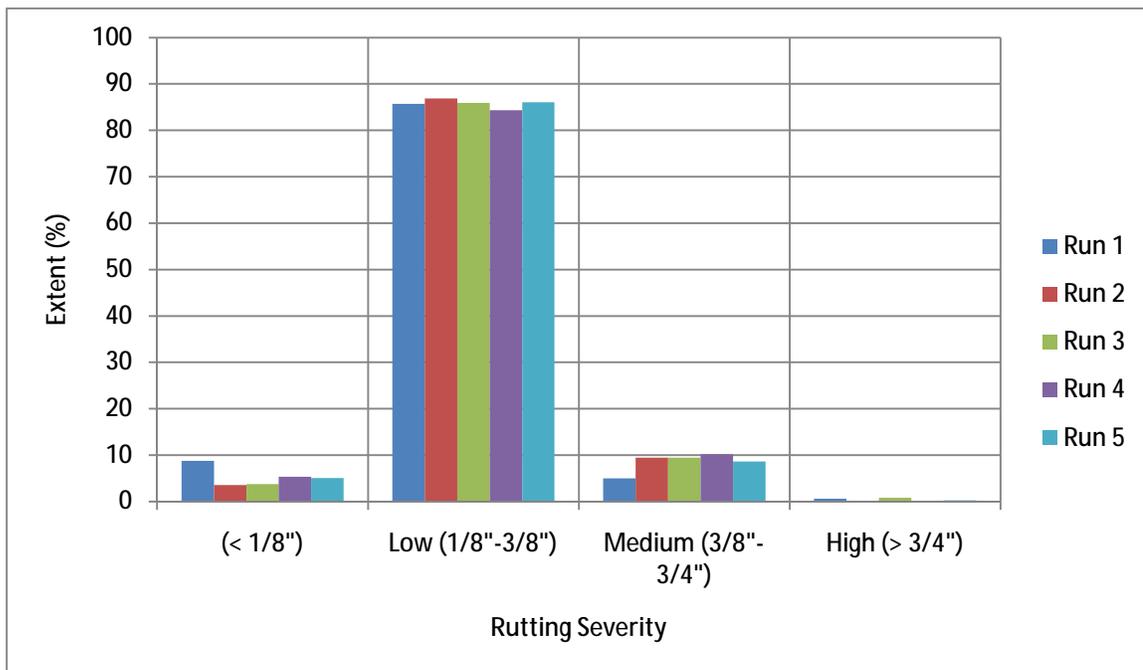
**Figure 4.18. Distribution of rutting by severity on SR-682 (LWP)**

Overall, the five runs show strong statistical similarity. There are some outlying data that created some dissimilarity in the first run; however, considering that these tests were run in an uncontrolled environment where the points do not align perfectly, pavement deterioration may influence measurements, and curves in the road may have influenced the driver's ability to remain at the center of the lane, the end results are convincing enough to deem the measurements repeatable. The distribution of data from SR-682 separated by PCR severity level is shown in Figure 4.18 and Figure 4.19. The distributions are similar between runs; however the inconsistency in the left wheel path data from run 1 is evident in Figure 4.18.

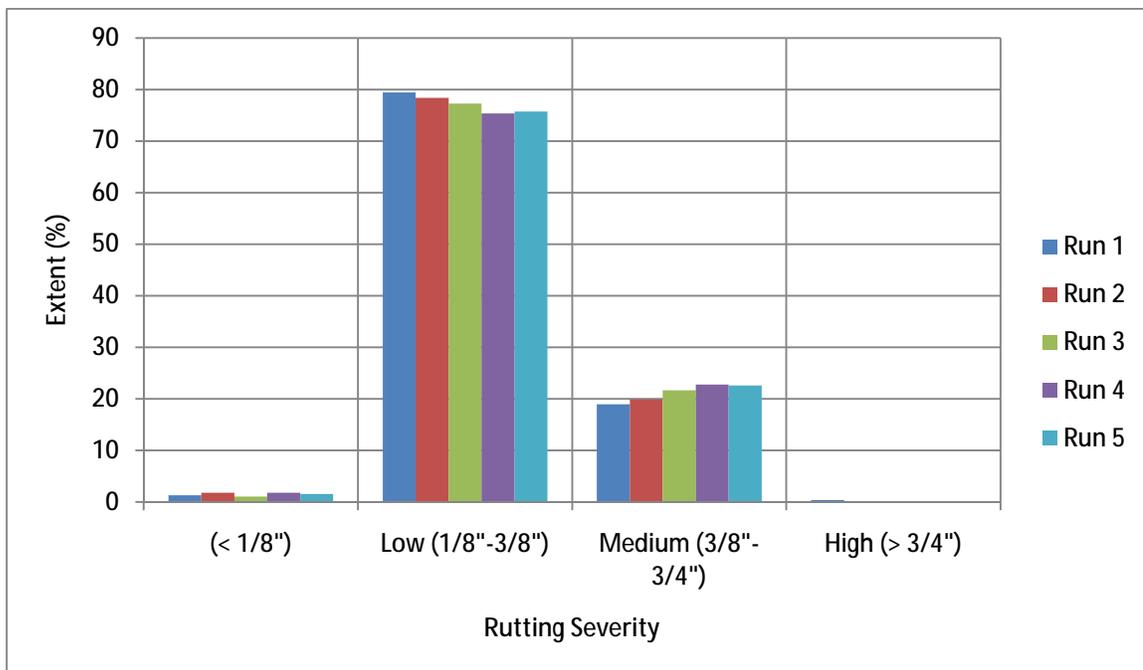
**Figure 4.19. Distribution of rutting by severity on SR-682 (RWP)**
