Evaluation of the Automated Laser Rut Measurement System Used by the Ohio  
Department of Transportation

A thesis presented to  
the faculty of  
the Russ College of Engineering and Technology of Ohio University

November 2011

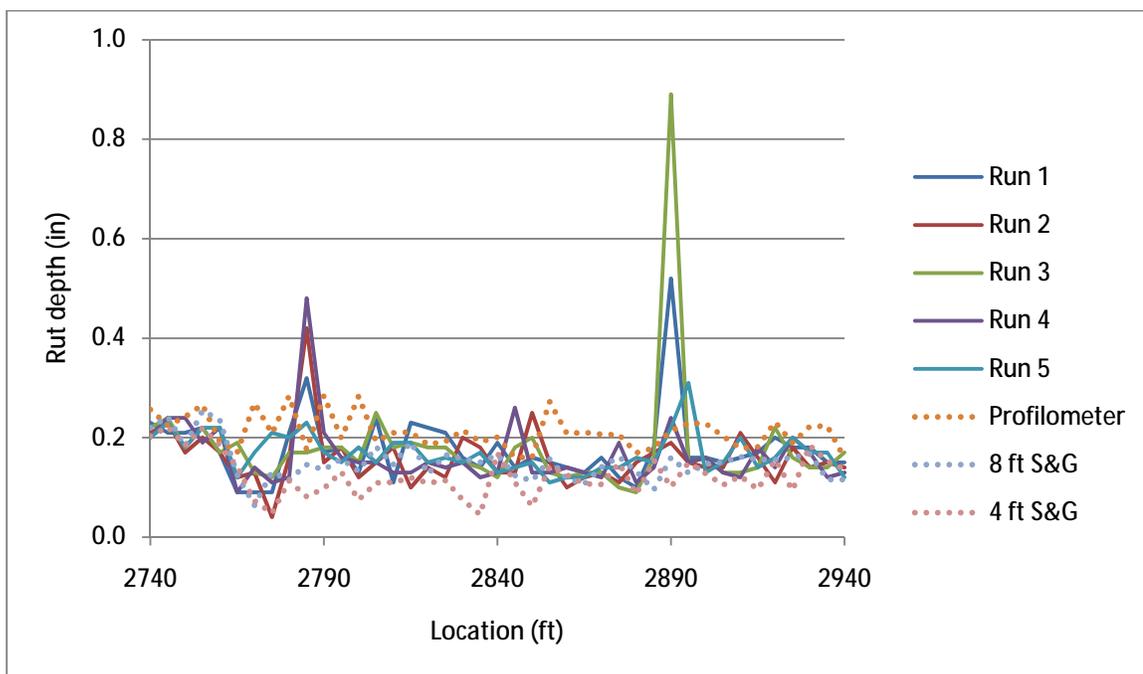
**Figure 4.20. Rut depth measurements from the 200-ft (60.96 m) test section on SR-682 (LWP) (1 in = 25.4 mm)**

The LRMS data correlate well with the 8 ft straight edge in all cases; however the profilometer measurements correlated with the LRMS readings only in the right wheel path. As one can see in Figure 4.20, the profilometer measurements are frequently higher than the other measurements. This is due to the deterioration in the left wheel path and near the centerline as shown in Figure 4.17. Small pits in the roadway surface are read by the profilometer wheel and create low points in the profile that are interpreted as the bottom of the rut by the rut depth algorithm discussed in Section 2.4. An example of this is shown in Figure 4.22. The LRMS system may not be influenced by this type of deterioration due to the shallow angle at which the laser hits the pavement surface. Its effects may also be diminished by the filtering used in the Dynatest software. The data from the profilometer in the left wheel path of SR-682 is assumed to be flawed and is disregarded in the comparison of measurement methods.

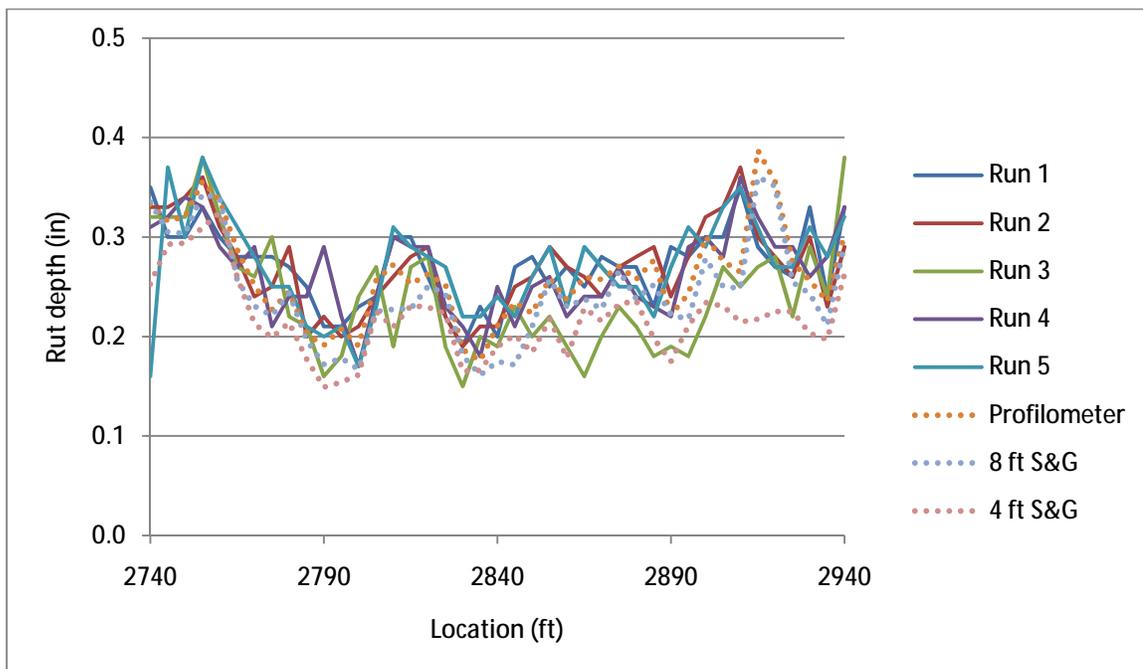
**Figure 4.21. Rut depth measurements from the 200-ft (60.96 m) test section on SR-682 (RWP) (1 in = 25.4 mm)**

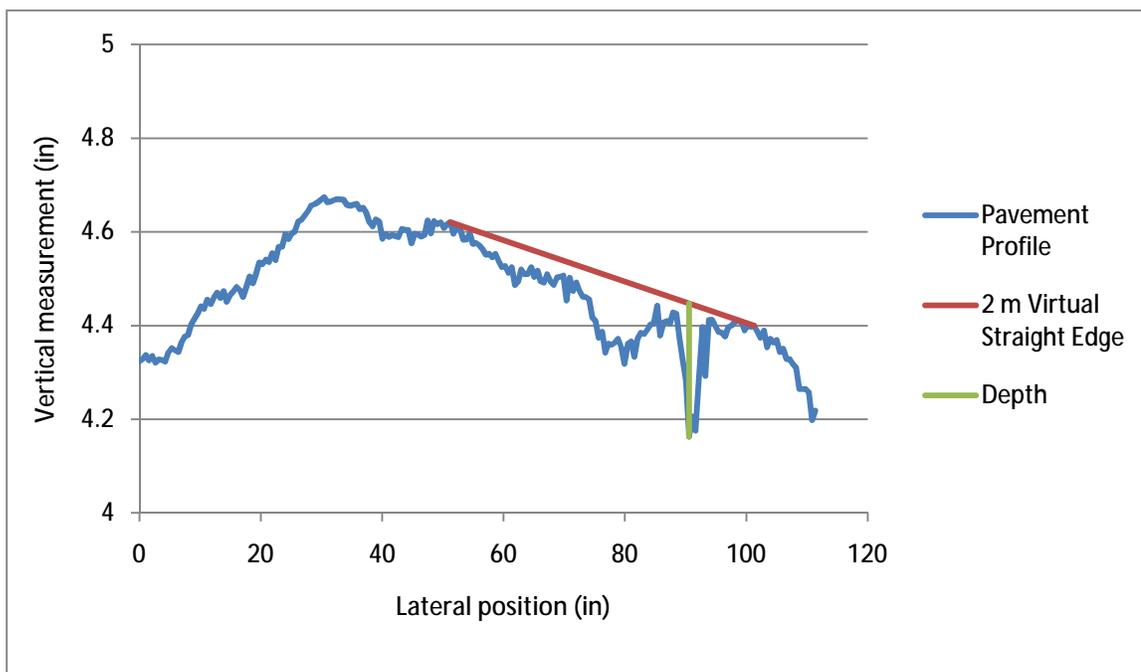
**Figure 4.22. Pavement profile from profilometer on SR-682 (LWP) where depth measurement was influenced by pavement deterioration (@ 2780 ft) (1 in = 25.4 mm)**

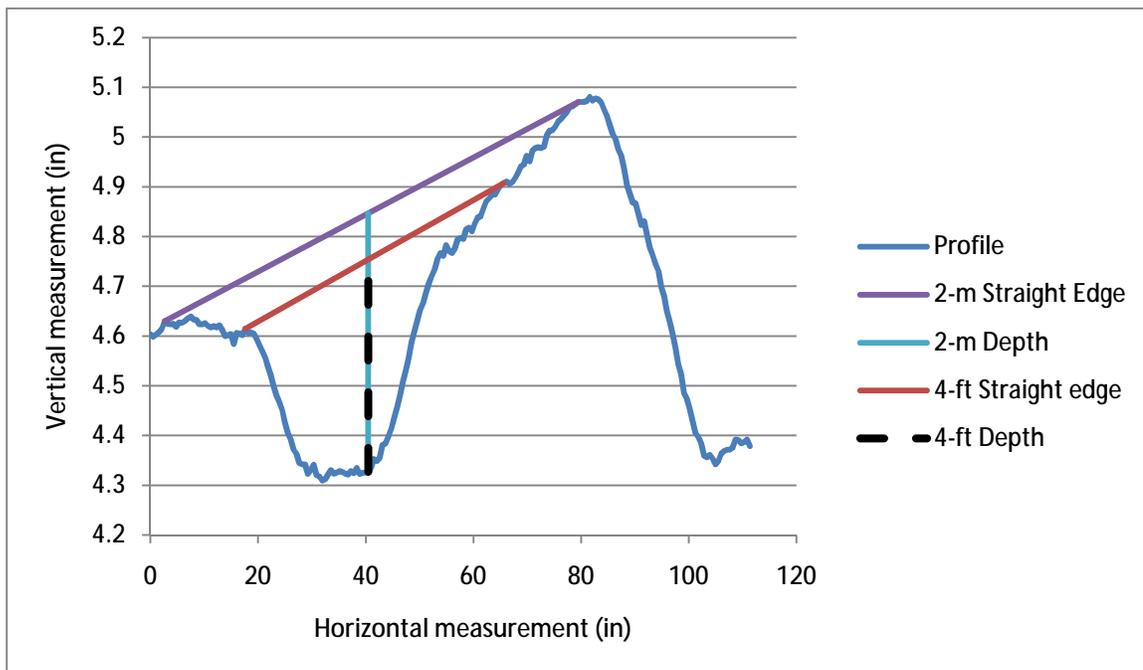
*Figure 4.23. 2-m and 4-ft virtual straight edge models (1 in = 25.4 mm)*

When compared to the profilometer and 8-ft straight edge, the LRMS showed a satisfactory level of accuracy and precision. With the exception of the profilometer data from the left wheel path of SR-682, the differences in measurements were statistically insignificant. Measurements taken by the 4 ft straight edge during both tests were generally inconsistent with the profilometer and 8-ft straight edge. Figure 4.23 shows a profile of US-30 created by the profilometer with a 2-m virtual straight edge and a 4 ft virtual straight edge. The 4-ft straight edge is clearly unable to span the entire rut. This may not always be the case, since the validity of the 4-ft straight edge measurement is dependent on the width of the rut; however, because the potential for significant error exists when using this length of straight edge, its use should be discontinued.
