TPF-5(299) Improving the Quality of Pavement Surface Distress and
Transverse Profile Data Collection and Analysis

May 6, 2014 – Rick Miller

AUTOMATING KANSAS PAVEMENT CONDITION DATA COLLECTION

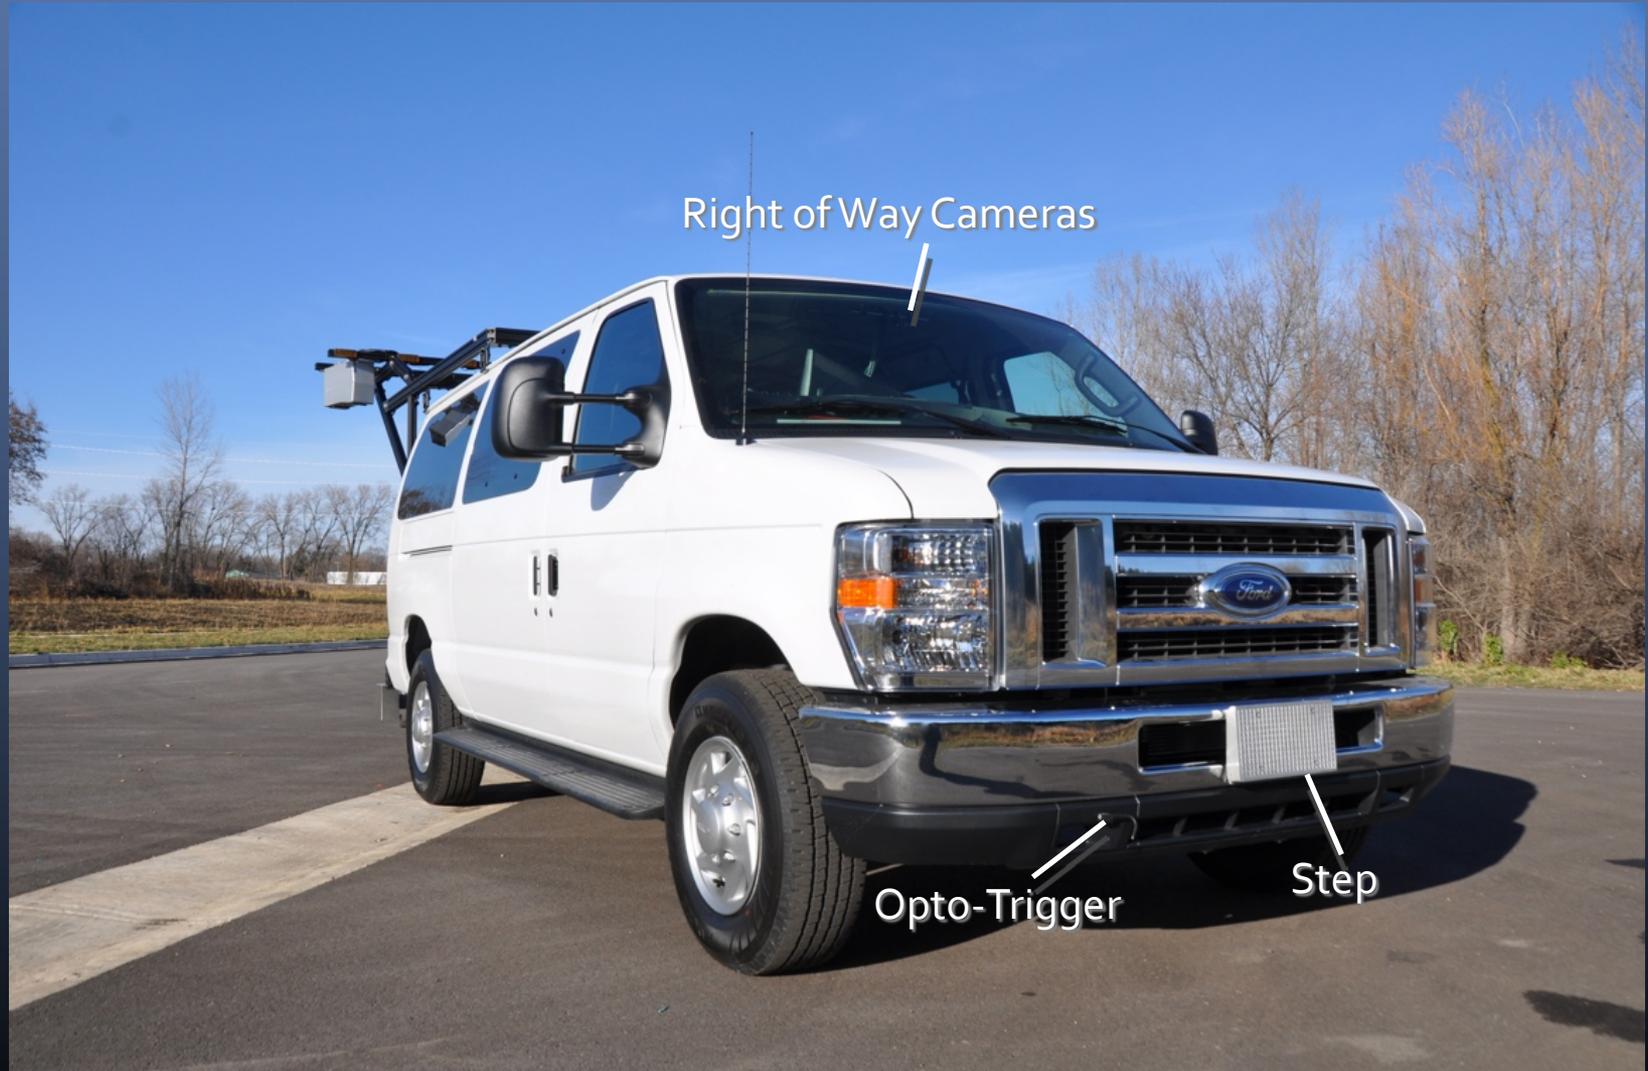
Kansas Pavement Condition Data Collection Vehicle

- Summer 2012 Purchase
- December 2012 Delivery
- Mandli Communications
 - Vehicle (Ford 1T Van)
 - Road Surface Profiler (Dynatest)
 - Forward and Downward Imaging (Allied Vision And Pavemetrics)
 - GPS
 - IMU (Applanix)

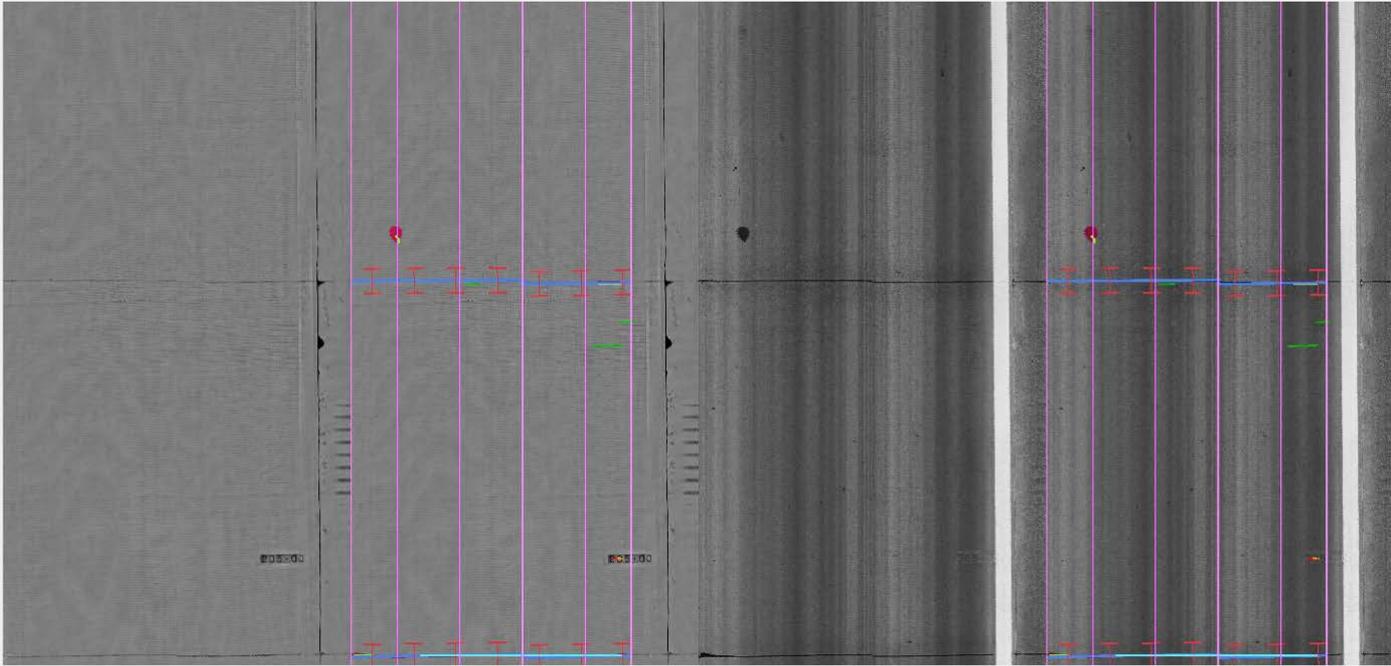
Concrete Range and Intensity

Output	Profile Viewer
Route	089U000750S0~2
Route Mileage	3.8759
Route Mileage Range	-0.0139 - 4.4610
Frame	118
Heading	145.23747
Latitude	38.92194912
Longitude	-95.70214605
Altitude	284.37389992

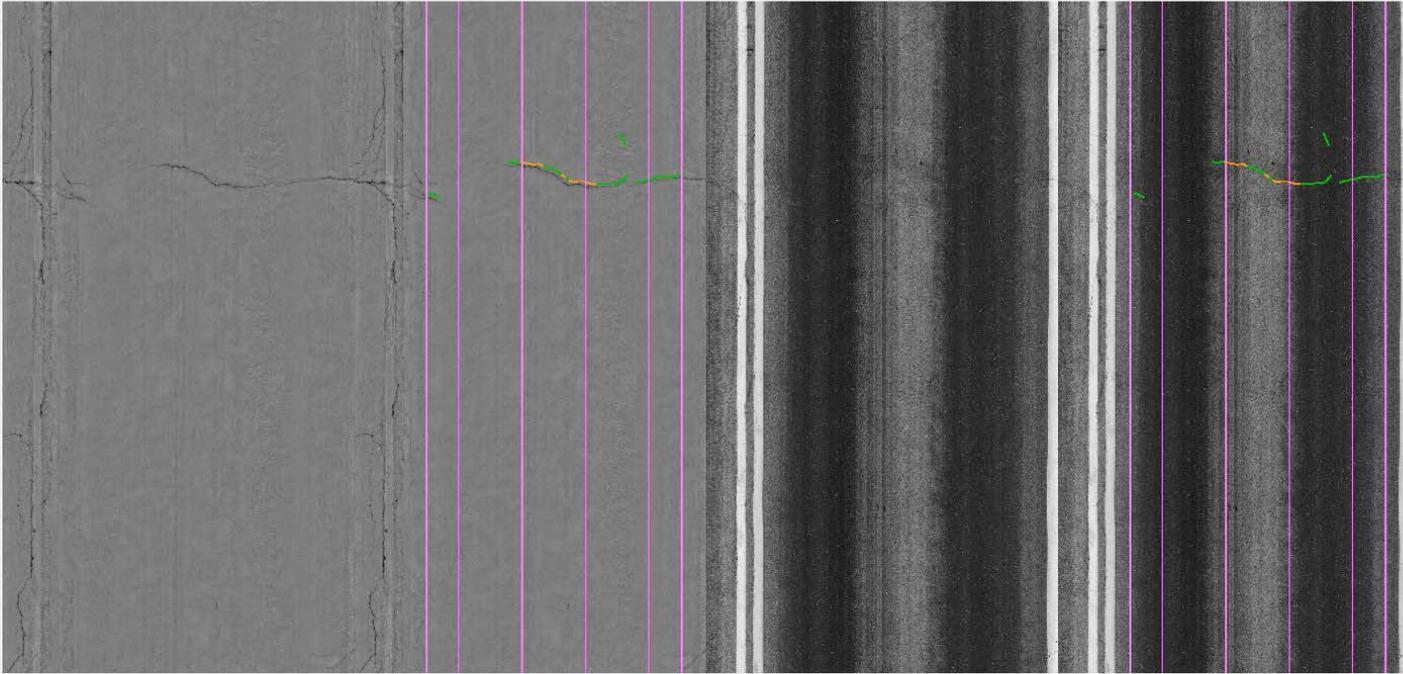
Range and Intensity on U-56

Route	070U000560S0
Route Mileage	23.1990
Route Mileage Range	22.9790 - 32.8274
Frame	45
Heading	90.47824
Latitude	38.78263041
Longitude	-95.67899260
Altitude	314.23305422

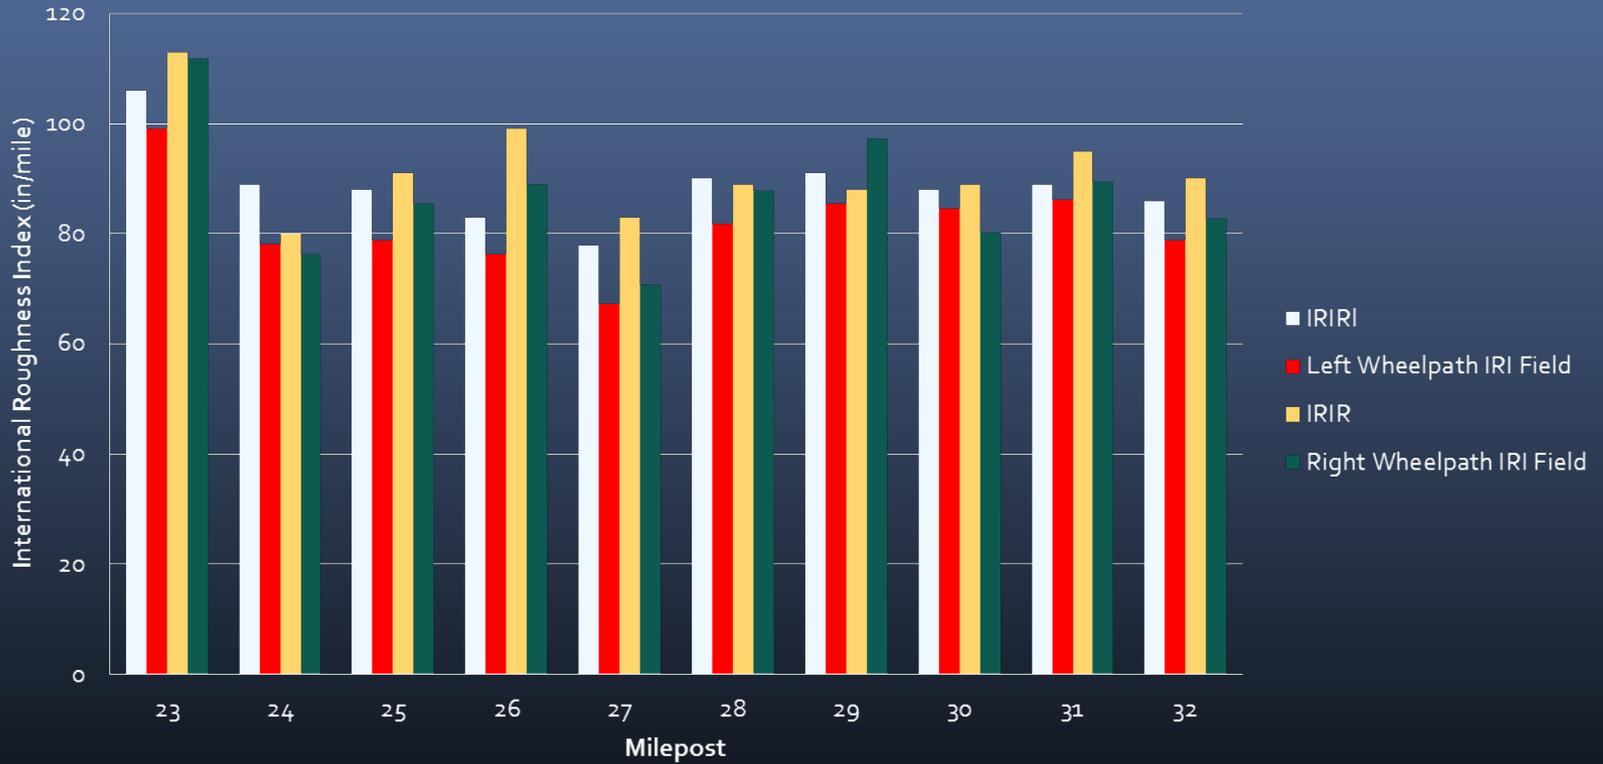
2012 NOS vs 2013 RSP IRI

2012 NOS IRI vs 2013 RSP IRI Values
070U0005600SoEB

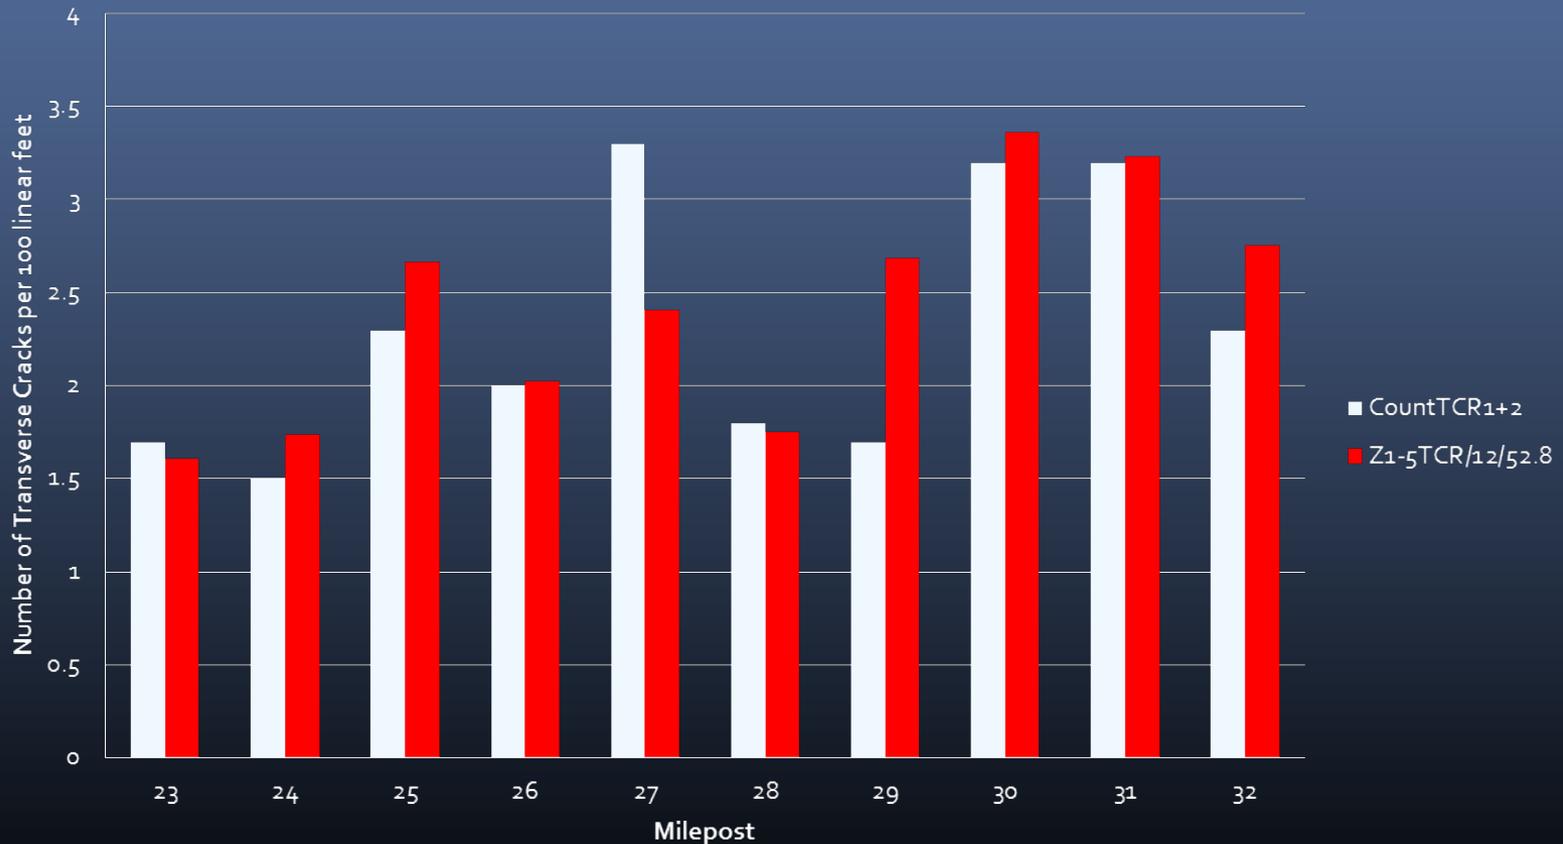
Comparing Transverse Cracks

2012 NOSTCR₁₊₂₊₃ vs 2013 LCMS Transverse Crack Values
070U0005600SoEB

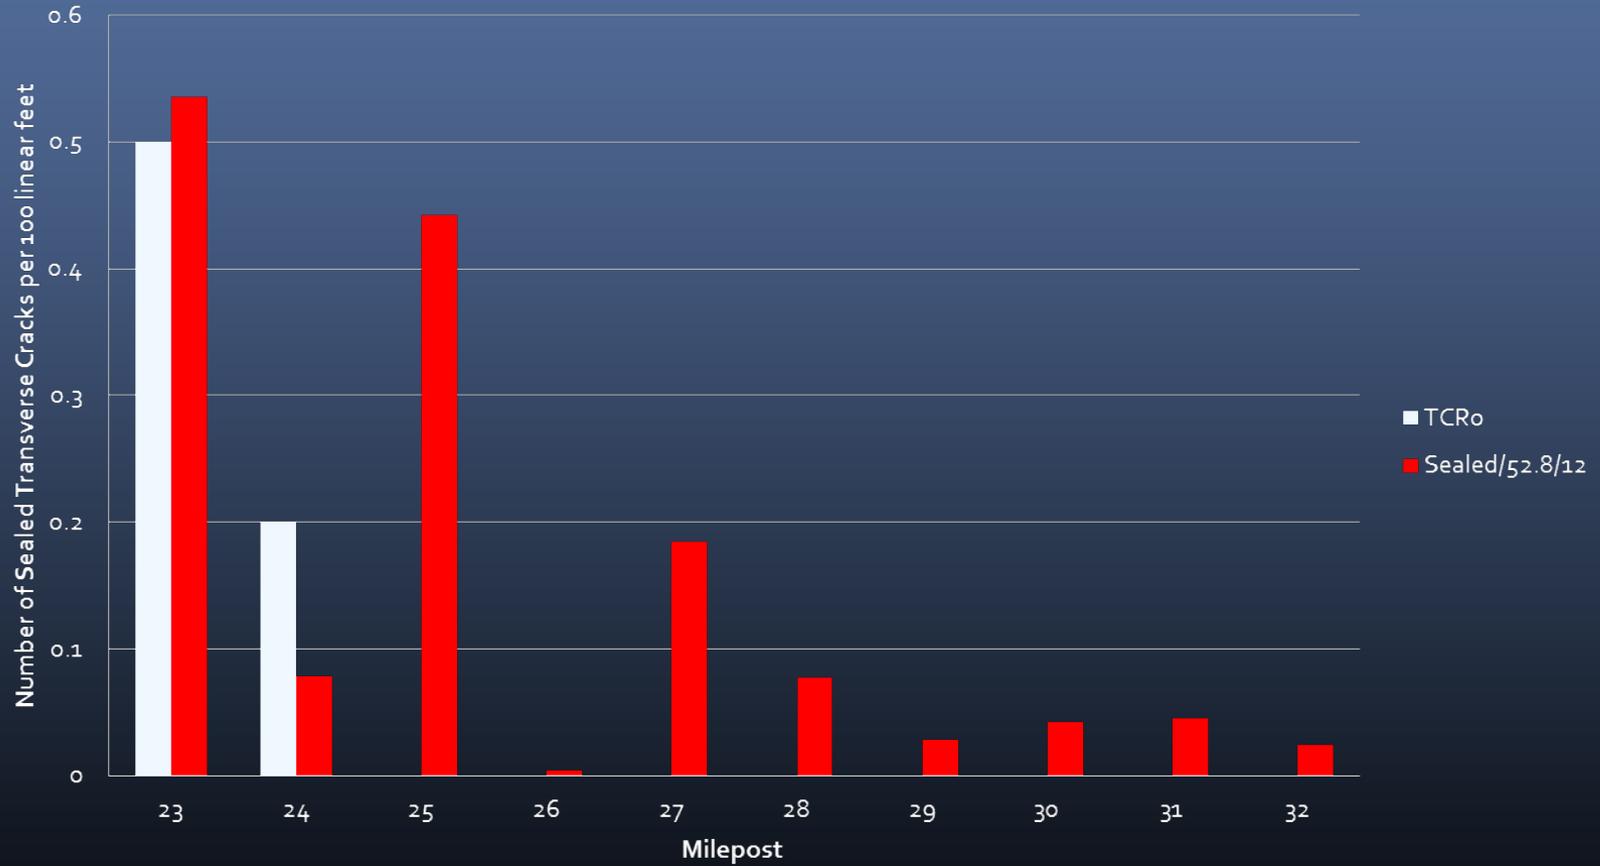
2012 NOS Sealed Transverse vs LCMS Sealed Cracks

2012 NOSTCRO vs 2013 LCMS Sealed Crack Values

070U0005600SoEB

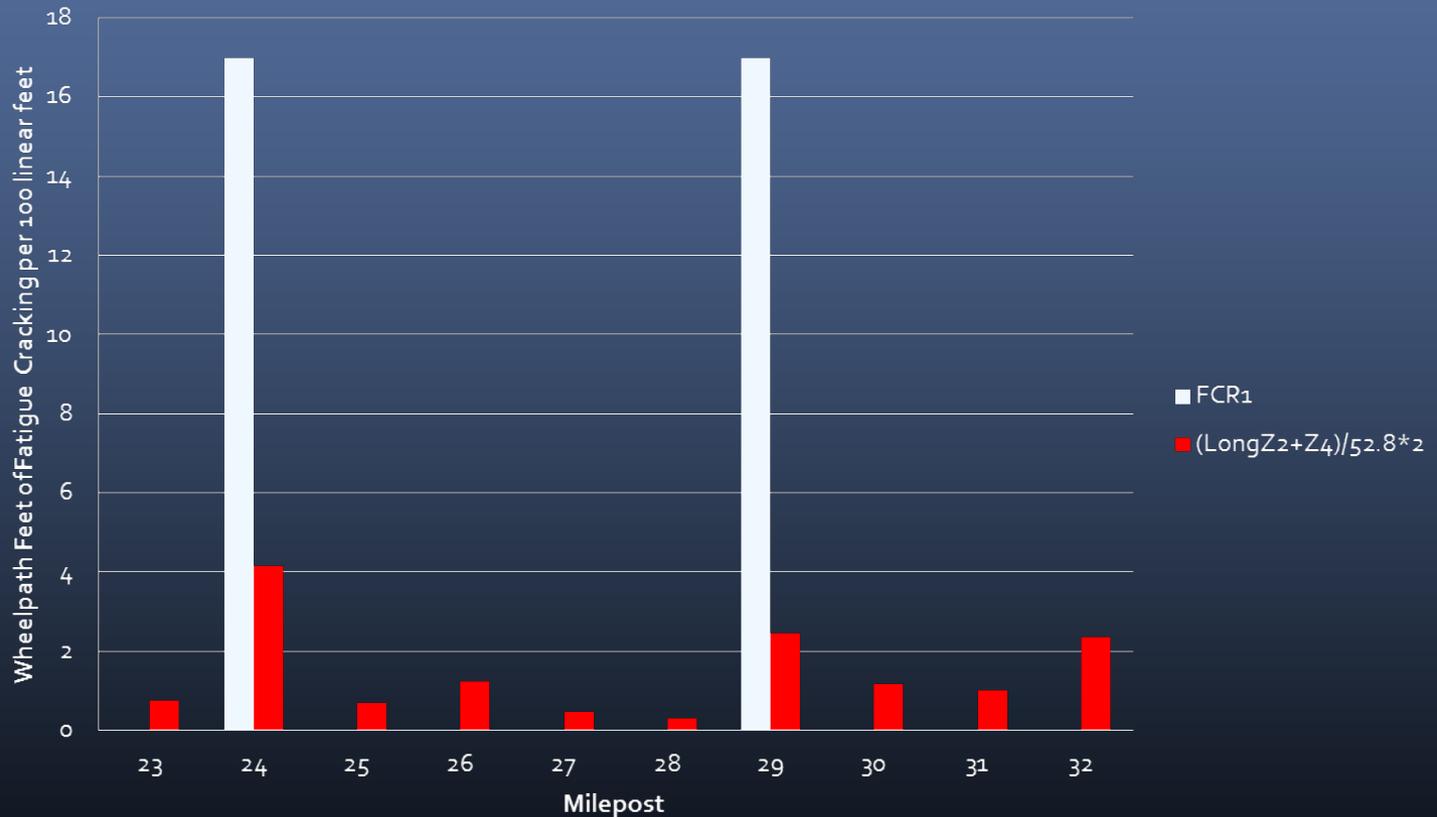
Fatigue Cracking Comparison

2012 NOS Fatigue vs 2013 LCMS Zone2+4 Crack Values
070U0005600SoEB
